More than half a million litres of foam concentrate was provided by the Angus Fire Emergency Service. So what has been learned about refinery & storage tank fires from Buncefield? Mike Willson investigates.

Foam concentrates the mind –Buncefield revisited

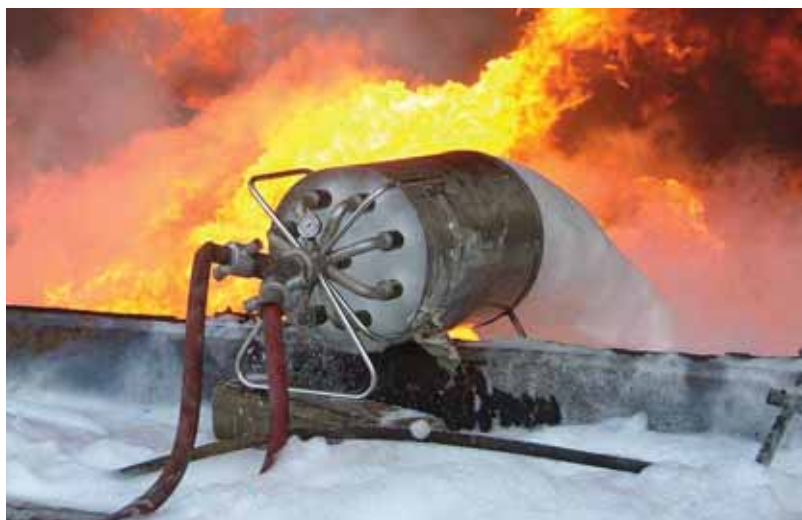
[Above] At Buncefield, large capacity foam monitors proved ideal for projecting high quality aspirated foam over long distances onto storage tanks. [Below] Angus foam makers at work in the Buncefield depot.

At incidents like Buncefield, large-capacity foam monitors are ideal for projecting high quality aspirated foam over long distances up on to storage tanks. But can the site fire water main be relied on to deliver sufficient water volume and pressure to operate them?

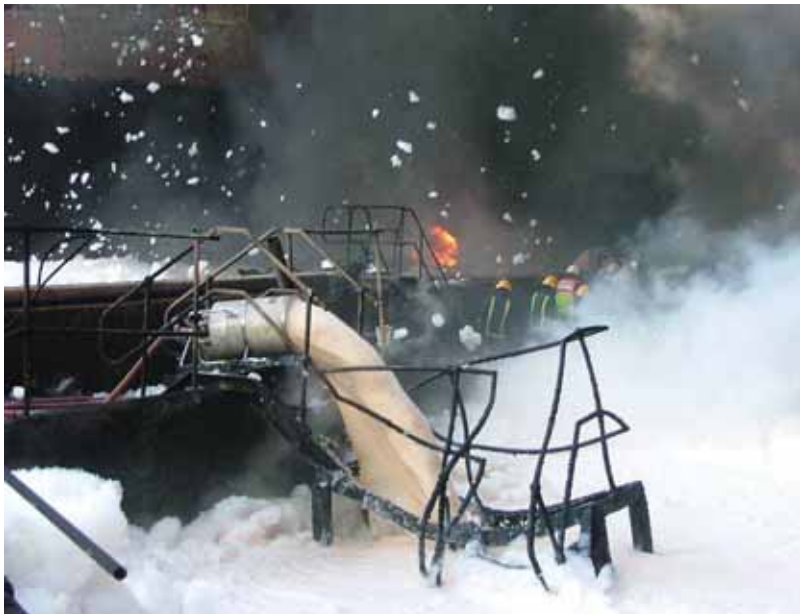
Angus foam pourers establish a foam blanket within the bund.

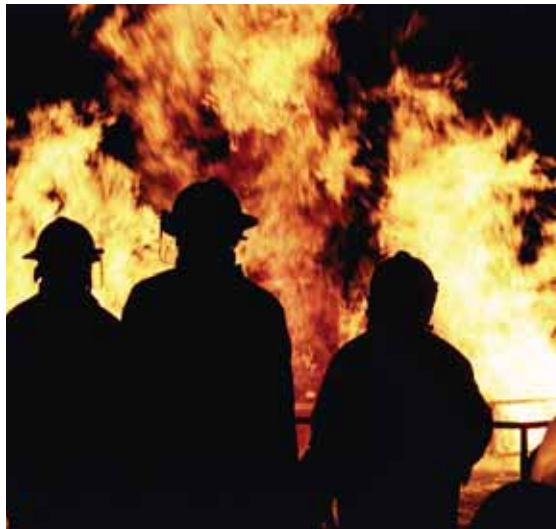
[Left] Extinguish a larger fire inevitably means using much larger quantities of foam. Existing international standards assume a single tank is on fire and only take into account the extinguishing phase. [Below] Angus Fire won a major contract to supply SembCorp Utilities UK with Tridol ATF 1x3 fire fighting foam. Based on Teesside in the North of England, SembCorp provides emergency response services to one of the highest concentrations of refineries in Europe.

Planning to extinguish a much larger fire inevitably means using much larger quantities of foam. Existing international standards like NFPA 11 assume a single tank is on fire and only take into account the extinguishing phase.
